# Service Bulletin

## 2001-2004 GL1800/A Trunk Opener Unit

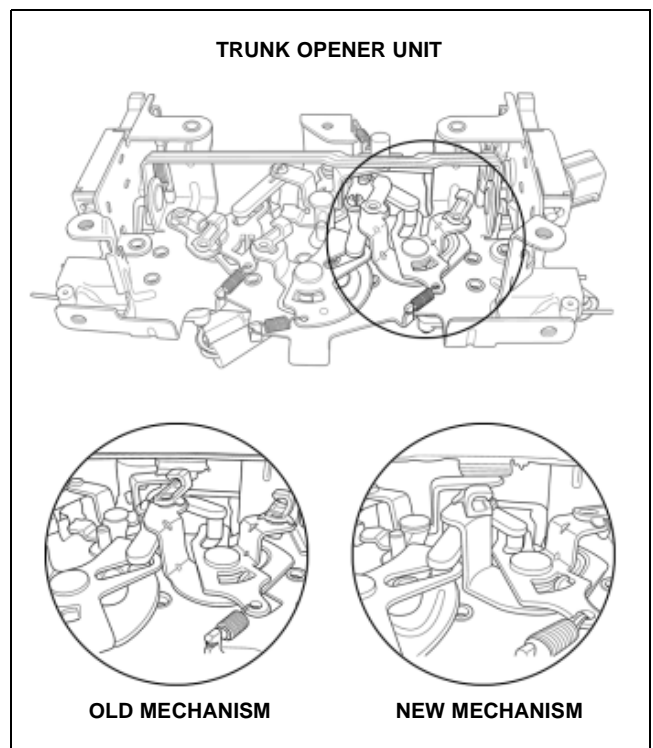
### PART DESCRIPTION

Some customers may experience trunk or saddlebag lids not opening when the corresponding latch lever is pulled.

To correct this condition, the opener mechanism must be replaced with a new opener mechanism.

**Opener Unit**  
P/N: 81310-MCA-A22  
H/C: 7700768
